Structural Steel Coatings for Corrosion Mitigation

Prepared by
Missouri Transportation Institute
and Missouri Department of
Transportation

FINAL Report

October 2010

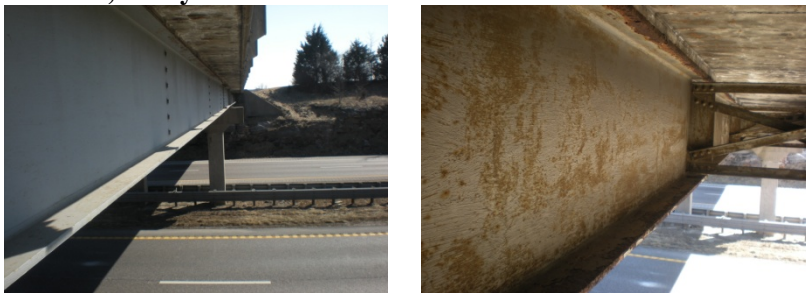
SYSTEM S					
Coating less than 5 years					
Bridge Number	Paint Year	TMS Condition	End- Span Field Rating	Mid-Span Field Rating	Overall Field Rating
A0048	2006	Good	Fair	Good	Fair
A0095	2006	Good	Good	Good	Good
A0491	2006	Good	Very Poor	Very Poor	Very Poor
A0491: Facia girders were in good condition, mid- span was in very poor condition, partially recoated, old system is not available.

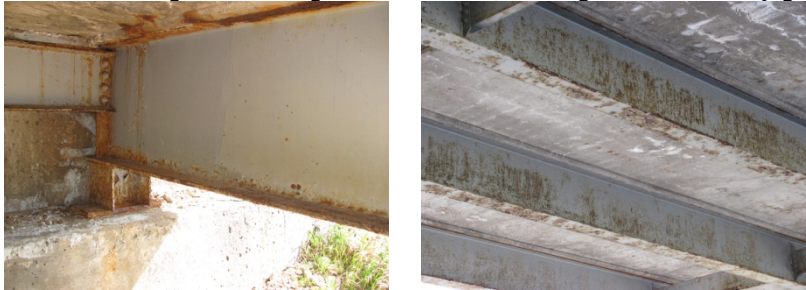
S0352	2006	Good	Poor	Poor	Poor
A0025	2006	Good	Poor	Very Poor	Very Poor
A0025:End- span was in poor condition, mid-span was in very poor condition. Partially recoated.

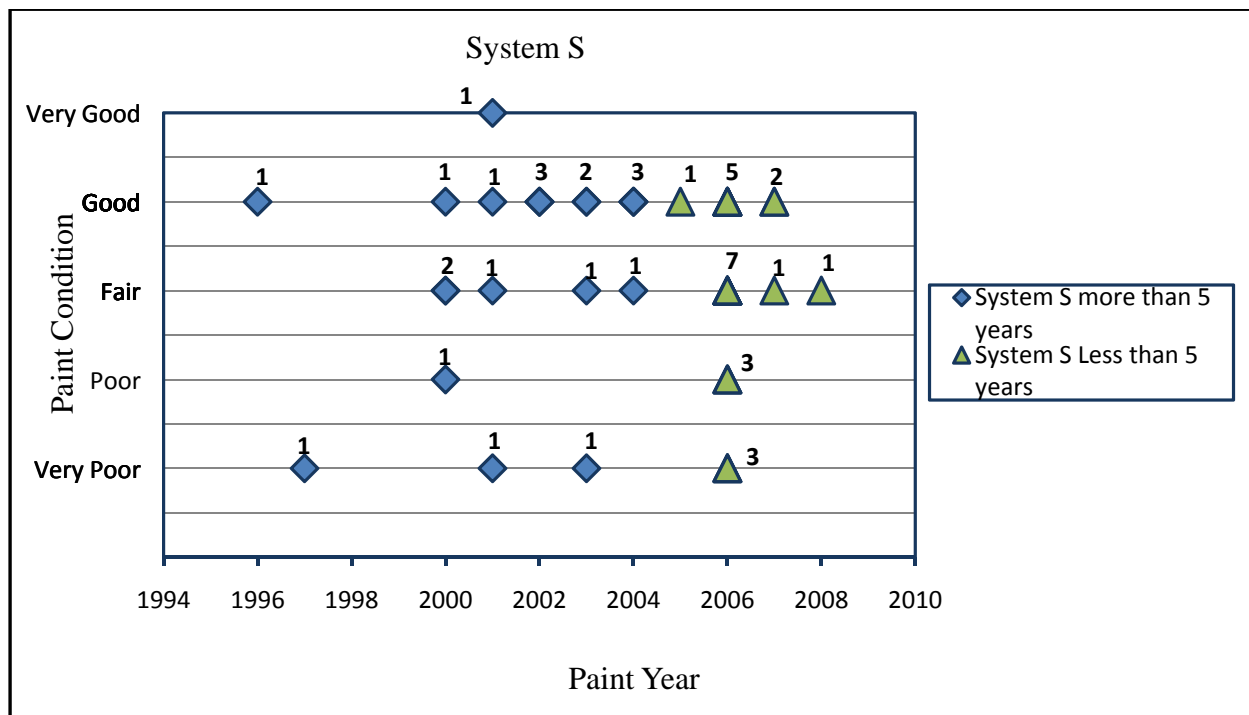
Figure 4.1 Summary of Conditions for System S Overcoatings.

When considered within the context that bridges with system S coating are less than 5 years old, the data suggests the overcoating process can be successful in extending the service life of the coatings. Based on observations in the field and discussion with experts, it would appear that the variations in the performance are likely related to a combination of the variations in the effectiveness of surface preparation and the severe damage that is present at the time of the over-coating. Figure 4.1 shows the coating conditions observed as a function of the time in service for the coatings. As shown in the figure, the age of the recoating does not appear to correlate with the condition of the coating, such that the condition of the recoating does not appear to be time-dependant, which further suggests that the condition is driven by factors such as surface preparation and localized environment.

Given that the expected service life of the over-coating can realistically be estimated in the range of 10 to 15 years, the data from the field evaluations indicates that this service life in many cases is being achieved, with isolated cases of early failures.

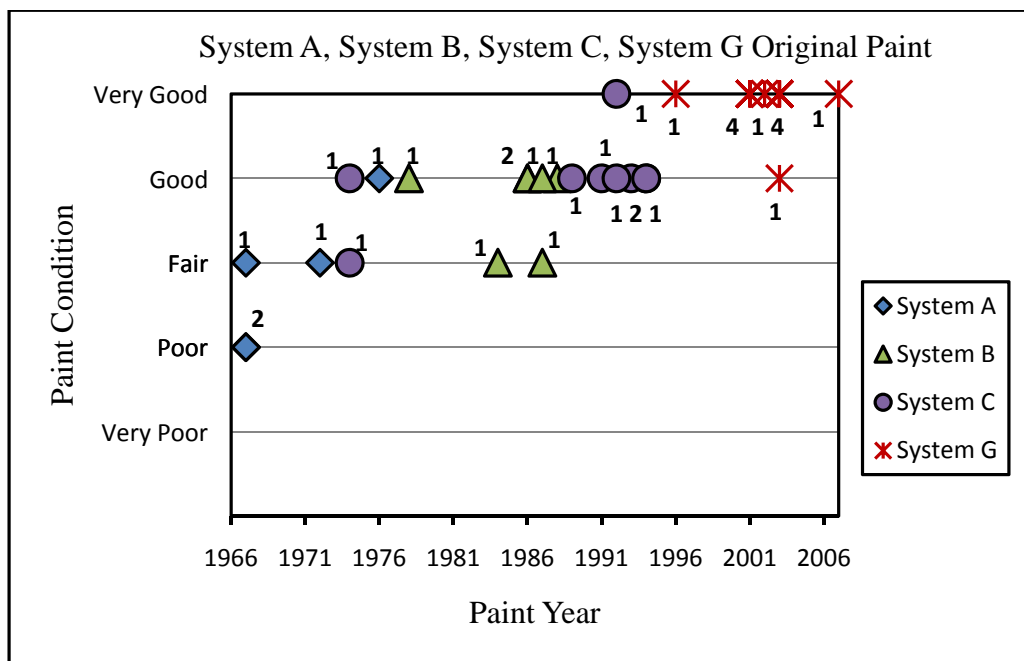
Figure 4.8 Condition Evaluation of Original Coating Systems.

The overall performance of the different original coating systems is shown in Figure 4.8. As shown in the figure, System G coatings are contemporary coatings that have had, so far in their service lives, very good performance in the field. Among the other systems that exist on the system, several are in poor or very poor condition. In each case, this degradation can be explained not by the service life of the coating, but by the drainage condition at the bridge as currently discussed. It should be noted that there are a number of original coating systems in the 30 to 40 years of service life range that are in fair to good condition. These bridges typically have very good drainage characteristics. Of course, what is missing from the data is the number of these older systems that have previously failed. The population of system A, B and C coating systems is somewhat skewed in terms of illustrating the overall performance of the coating systems since the time of their original application. Coating systems that have previously failed and have been replaced or overcoated are no longer available for evaluation, and therefore the coating systems failures are not included in the available population. However, among those systems that are available, it is clear that the most important factors in the performance of the systems are the drainage condition at the beam-end and the deck condition.

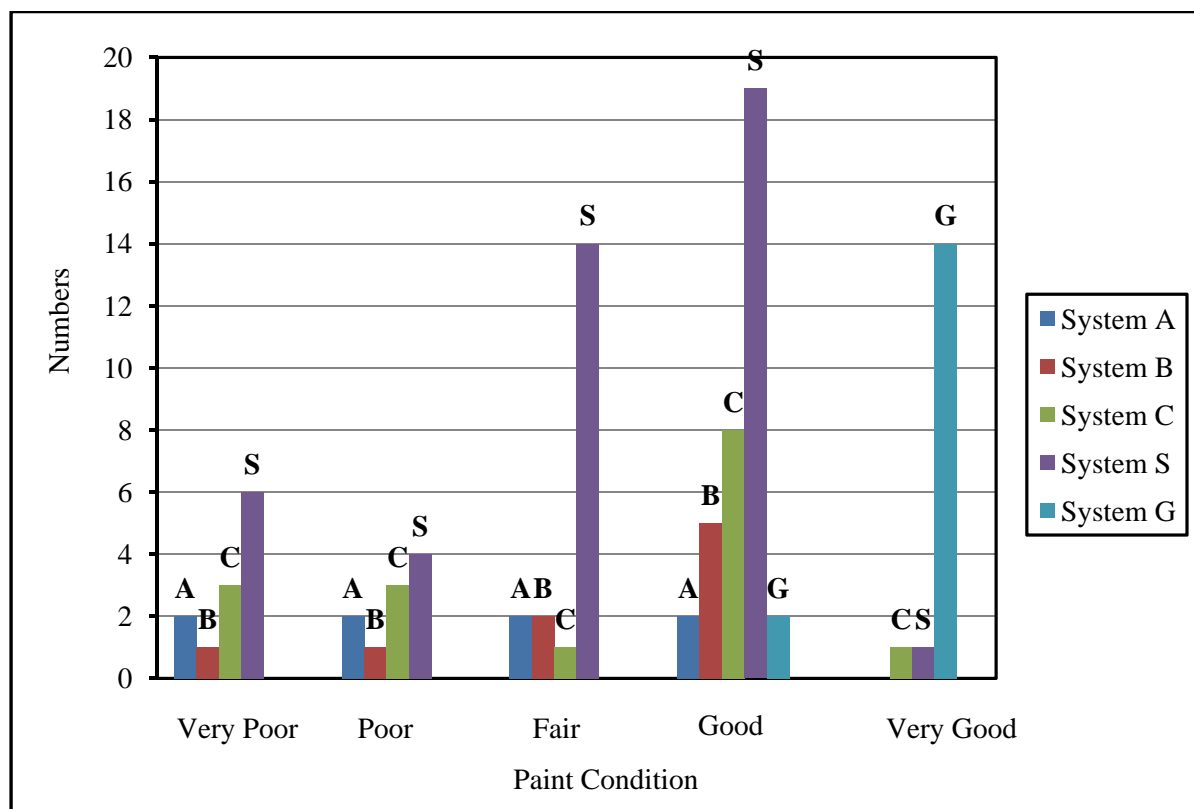
Figure 4.9 Overall Summary of Coatings Conditions Observed in the Study.

Figure 4.9 summarizes the overall evaluation from all of the bridge observed during the course of the research, according to the current condition evaluation of the coating system. This overall data shows what could be expected, the older coating systems are typically in worse condition, the newer systems in better condition, generally. Of note in the figure is that the system S overcoating have a number of cases where their condition is poor or very poor. The system A, B, and C, which are typically much older, have many cases where their condition is above expectations given their age, these systems are in fair or good condition even after many years of service. In virtually every case, the performance of the coating systems results directly from the drainage conditions at the bridge. For system S coatings that have performed poorly, the existing coating system that was overcoated was in poor condition and the drainage continues to effect the overcoating. For system A, B and C systems that are performing well, the surface of the steel has been kept dry by proper deck drainage and/or deck rehabilitations. One assumes that a number of A, B and C coating systems have failed previously and have been recoated or overcoated, as previously discussed.
